# out damn spot

(or not, as the case may be)....

The following article explains some recurring problems with limestone and other porous paving materials. It does not conclude that limestone is unsuitable for these purposes. Nevertheless, there is always a risk that it will be misconstrued as a broad condemnation of limestone. The causes of the unsatisfactory results illustrated here are not inherent shortcomings in the paving materials themselves. These problems recur due to a failure to appreciate and make allowance for characteristic properties which differ from those of more familiar granites, dense marble, basalt, reconstituted stone and porcelain tiles. If appropriate precautions are taken in design and installation of paving and flooring of relatively porous stone, these problems can be avoided.

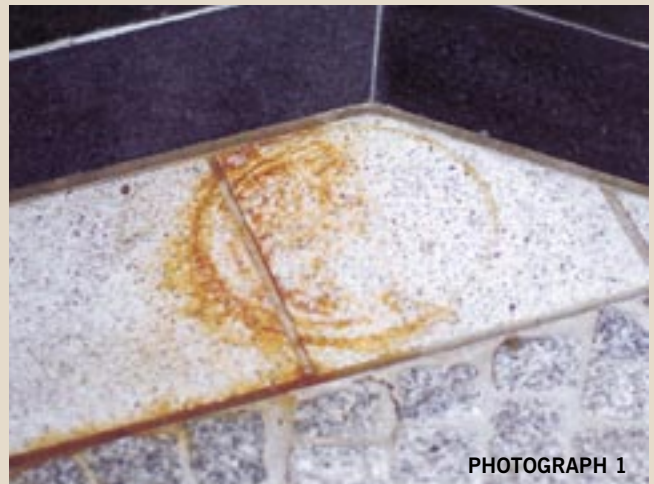
Simple discolouration is caused by the breakdown and diffusion of minerals with contrasting pigments such as iron oxides and hydrates (orange, brown and black) and sulphides (yellow and grey) or by run-off from rusting iron and oxidizing copper. Photograph 1 is almost self-explanatory; the base of a steel pail has deposited rust on reconstituted granite paving tiles and joint grout. The rust stains reflect light at the wavelength perceived as orange. Limestone walls at London's Canary Wharf display vivid green plumes below copper roofs and gutters. There are two components of reflected light; (a) that reflected directly at the surface, which is characteristic of the material's colour, and (b) that which is scattered, reflected and diffracted by fine-textured features of the surface. It is this scattered light which lightens the dry surface and dilutes the true colour of an object. What we mostly see in pigmented stains is light reflected directly from particles at the discoloured surface (see **Diagram 1**)

**PHOTOGRAPH 1** Rust staining on paving tiles. The wavelength of light reflected from the iron oxide at the surface is perceived as the characteristic orange colour of rust. The colour of the tiles and grout has been changed by an extraneous pigment.

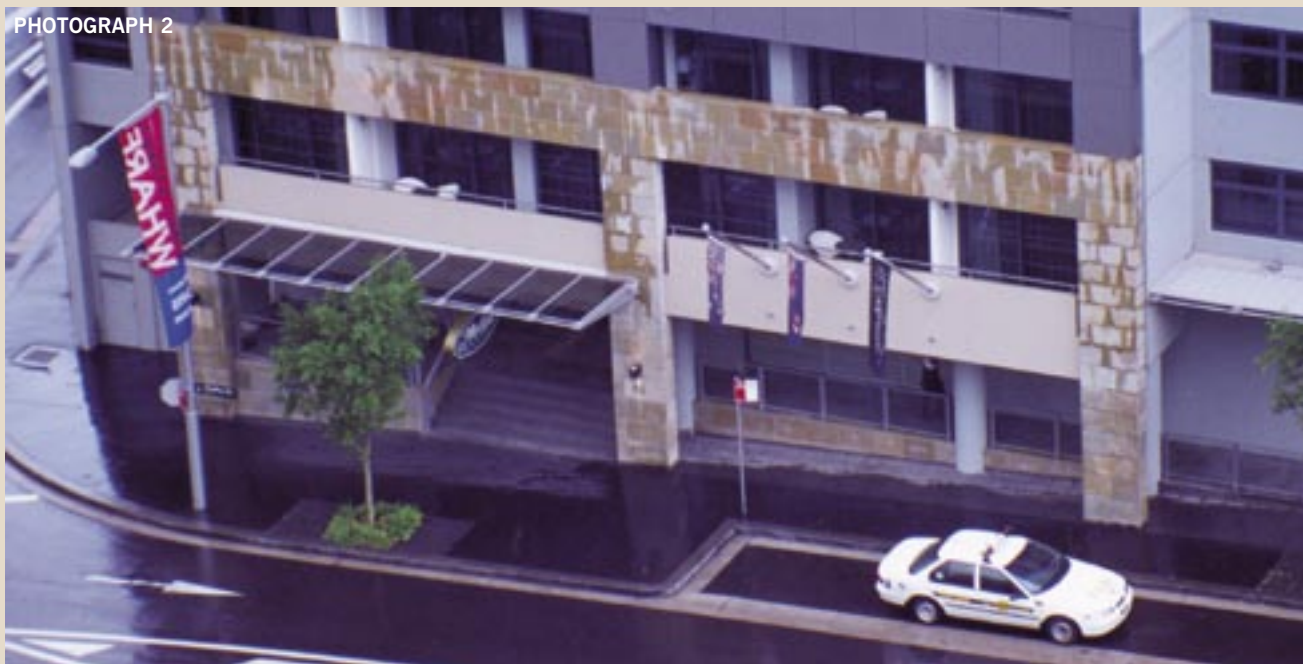
PHOTOGRAPH 2

**PHOTOGRAPH 2** Rainwater flowing down the surface of these slate tiles has not introduced an extraneous pigment. The perceived darkening of the wet surfaces occurs because more light is scattered below the tops of microscopic surface features and less is reflected towards the observer. The thin film of water acts as an anti-reflection coating which accentuates the true colour of the stone, as does the clear anti-graffiti coating on the ground floor columns.

Moisture causes light to scatter more efficiently and deeper into the material. As a light beam penetrates further into a damp surface, it is intercepted by more surface features. A fraction of the light is absorbed and some is scattered, so a decreasing proportion is reflected at each successive surface. By the time the remaining light is reflected and refracted within the object and back towards the observer, it has been further attenuated, i.e. its quantity has been significantly reduced. The observer perceives this lessened quantity of reflected light as relative darkness of the damp surface (see **Diagram 2 and Photograph 2**).

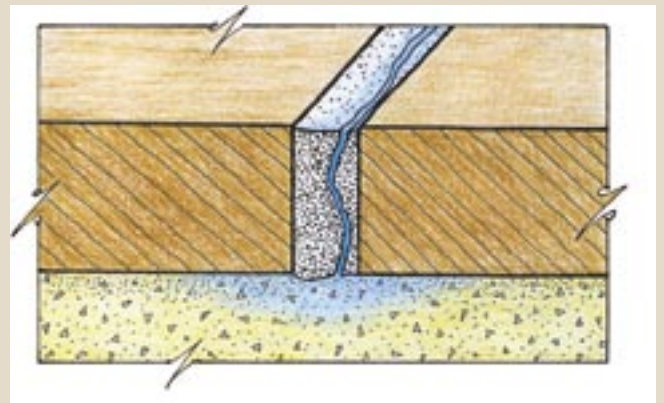
**DIAGRAM 3**

Rainwater and irrigation water seep downward through fine fissures in grouted joints and gaps in butt-joints. The water flows into sand-cement mortar bedding where it dissolves the calcium hydroxide which occurs in excess in hydrated Portland cement.

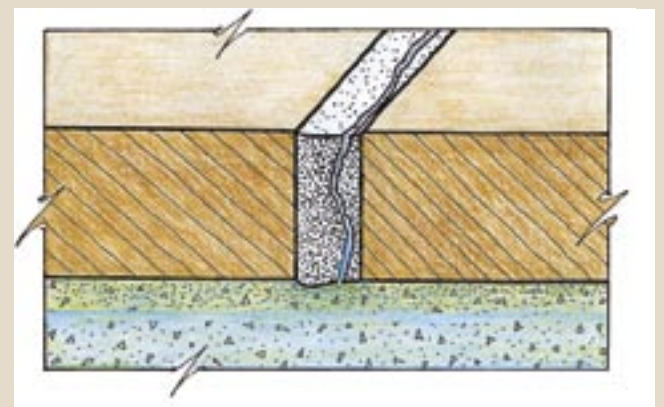
**DIAGRAM 4**

If the water does not drain efficiently from the bedding, the cement-rich mortar may become saturated. Fresh water flowing under the paving will then mix with and displace water tainted by dissolved calcium salts, also known as free lime. The solution rises back to the surface where it evaporates and reacts with carbon dioxide gas in the air.

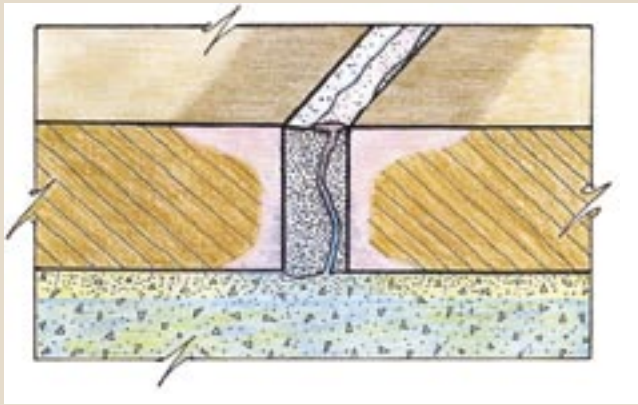
**DIAGRAM 5**

The last stage of picture-frame staining in porous natural stone and unglazed ceramic tiles. Solid crystalline calcium carbonate, from the reaction between atmospheric CO<sub>2</sub> and calcium hydroxide in solution, temporarily plugs up fissures near the surface. The highly alkaline solution below is forced into the joint grout and through nearby surrounding porous stone. Lime-tainted water from the bedding may also spread across and be absorbed at the surface. Pure calcium carbonate is white. When it precipitates in sub-surface pores in light-coloured limestone and marble, it alters the absorption, refraction and reflection of light in a way that causes the dark staining and wet appearance. The stains characteristically remain even when stone tiles are removed and completely dried in a soil laboratory oven.

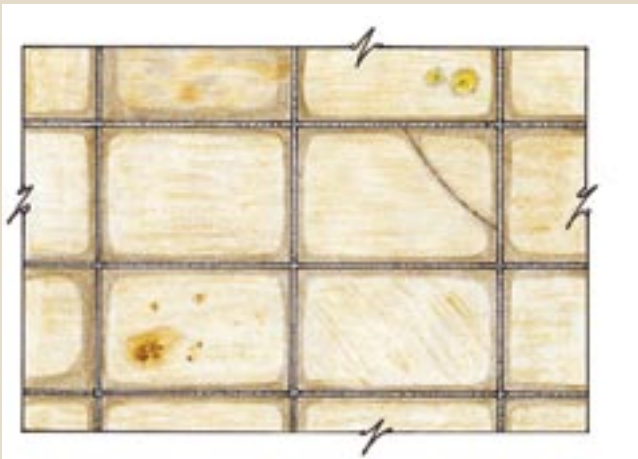
**DIAGRAM 6**

So-called picture-frame staining in porous limestone flooring and paving. Dark bands without differential pigmentation occur along grouted joints and butt-joints. Moisture meter measurements may show no significant differences in the moisture content between dark perimeter bands and unstained centres of tiles. Wetting of the stone from rainwater and moisture trapped in the bedding dissolves, transports and diffuses soluble iron minerals, notably orange and brown oxides and hydrates (concentrated at A and diffuse at B) and yellow and grey sulphides (in blooms at C). Picture-frame staining also occurs along some natural veins and flaws (D) which are more porous than the parent stone. These forms of staining also occur in some granites, marbles and other popular paving stones, in terracotta paving tiles and reconstituted stone. The fault is not in the paving material but in the methods of bedding and fixing.

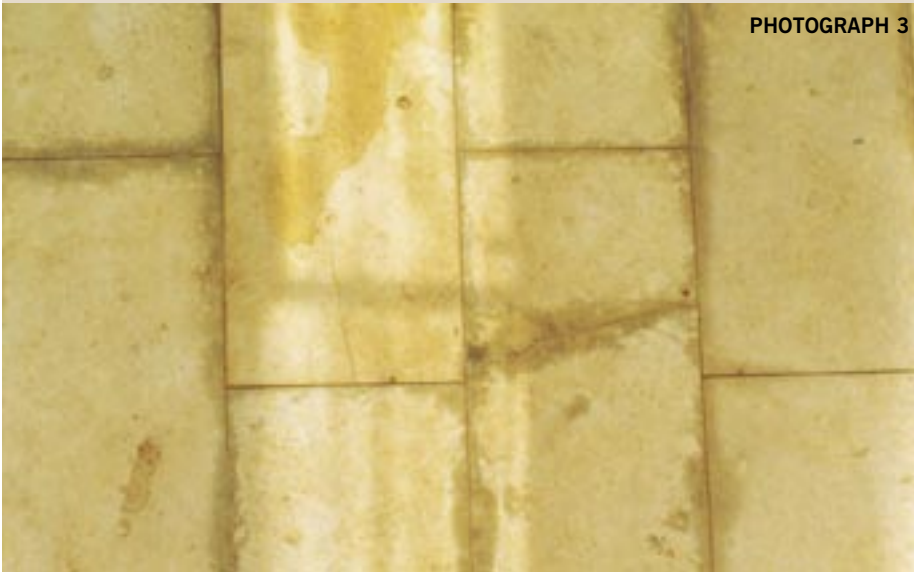
Picture-frame staining (**Diagram 6 and Photograph 3**) and other forms of dark staining which resemble surface dampness do not necessarily require the permanent or recurrent presence of moisture; they commonly occur in the aftermath of a single prolonged wetting. BDAP has been involved in a protracted dispute in which a contractor used radiators to warm stained white marble for three weeks before suspecting that seemingly damp stains were not caused by residual moisture. In another instance, marble and limestone tiles in hotel bathrooms were replaced twice before the actual causes of picture-frame staining were recognised.

**PHOTOGRAPH 3** *Picture-frame staining in paving of a porous Italian limestone, here photographed as the stone dried in sunlight after rain. Bands of dark stains along joints and natural fissures did not disappear when moisture meter readings confirmed that the surface of the stone was uniformly dry. In other words, the stains were not due to the presence of moisture at or below the surface. They were caused by deposition of water-soluble materials transported upwards from the bedding and through the tight grouted joints.*

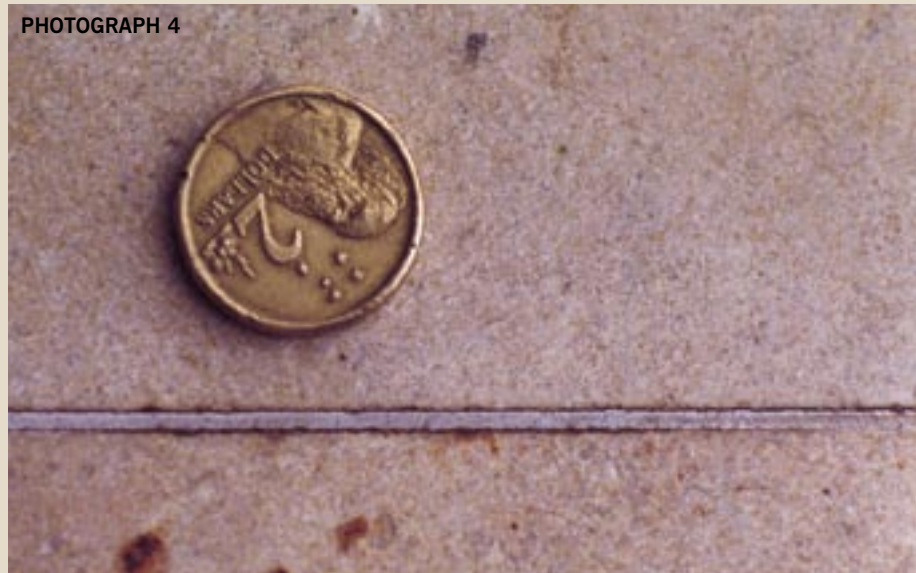
**PHOTOGRAPH 4**

*A close view of very fine gaps between abutting limestone paving tiles and a narrow cement-based grouted joint. The scale of the macrophotograph is close to 2:1. The joints are about 1.75 mm wide.*

*Narrow gaps along the sides of such joints are common in paving but are not readily visible from a normal standing position. They allow rainwater to flow into porous sand-cement mortar bedding.*

*Unless the water drains from the bedding faster than it is replenished, the bedding may become saturated. Water and dissolved constituents of the bedding will then rise to the surface through joints and fissures in the stone.*

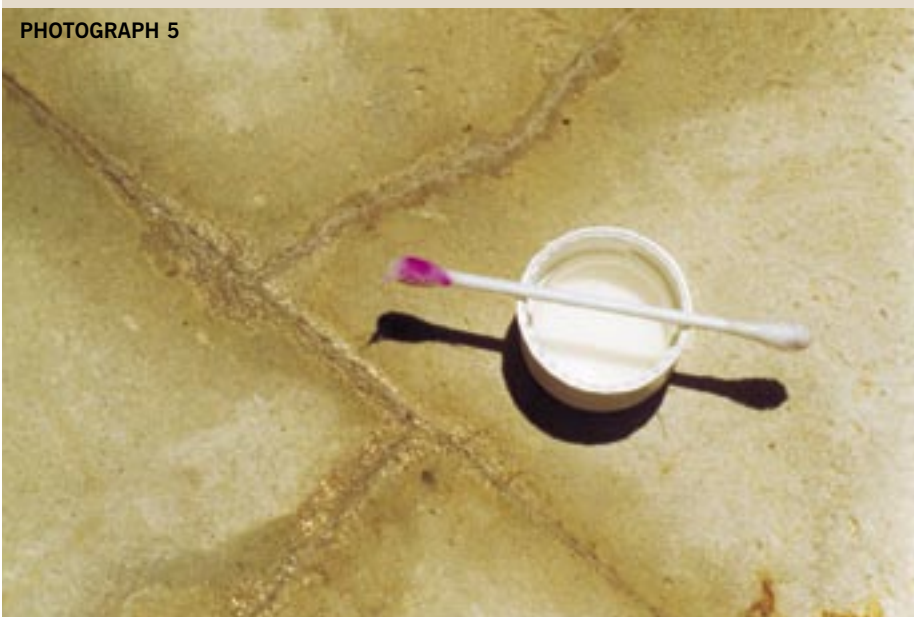
**PHOTOGRAPH 5**

*A close view of water percolating upwards through joints after the surface of the limestone paving dried in sunlight. The heat of the sun has caused moisture trapped under the paving and in the joints to convert to water vapour and expand. The vapour pressure forces water in fine gaps (see Photograph 2) to flow back to the surface. The water carries dissolved calcium hydroxide from Portland cement in the bedding. The hydroxide reacts with carbon dioxide in the air and is precipitated along the joints and natural fissures as dense white encrustations of calcium carbonate, a compound which is insoluble in hot water. The purple colour on the swab at the centre of the photograph is phenolphthalein indicator dye which changes from clear to magenta at a pH of about 10. The dye has been used here to confirm that water along the joints is highly alkaline, i.e. it is not fresh rainwater but water which has carried dissolved calcium hydroxide from Portland cement in the bedding layer.*
