Deterioration of Thin Marble Cladding a major international study

by **Bent Grell** Ramboll, Copenhagen, Denmark, **Björn Schouenborg** SP Swedish National Testing and Research Institute, Borås, Sweden, **Katarina Malaga** SP Swedish National Testing and Research Institute, Borås, Sweden

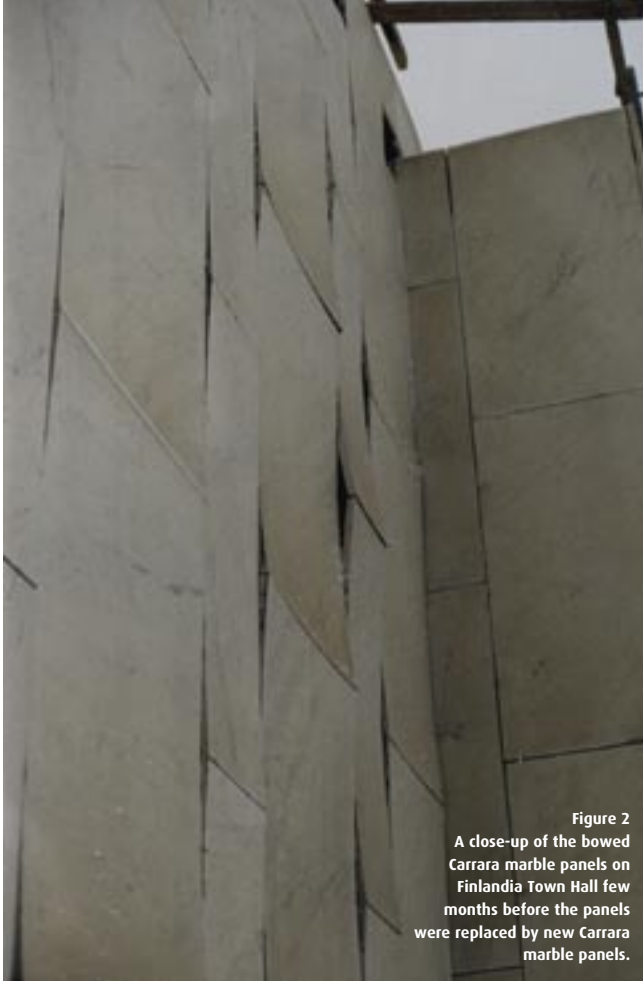
Figure 2
A close-up of the bowed Carrara marble panels on Finlandia Town Hall few months before the panels were replaced by new Carrara marble panels.

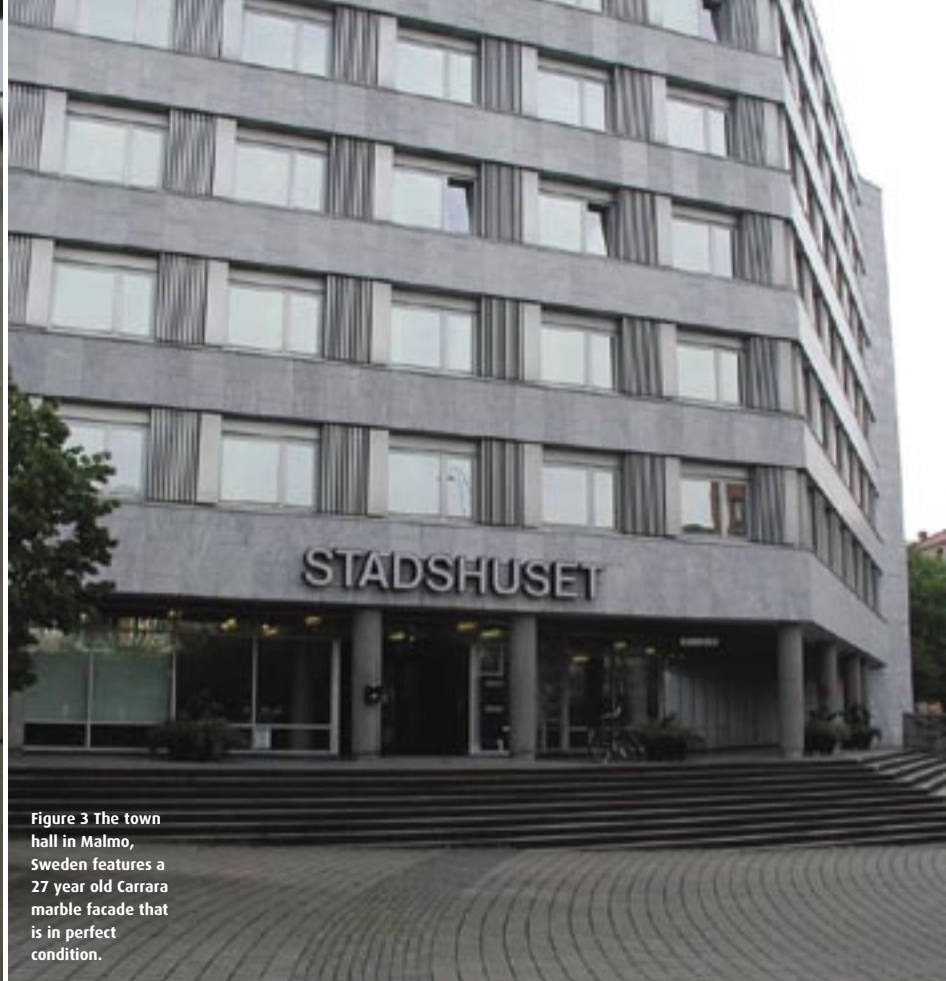
Figure 3 The town hall in Malmo, Sweden features a 27 year old Carrara marble facade that is in perfect condition.

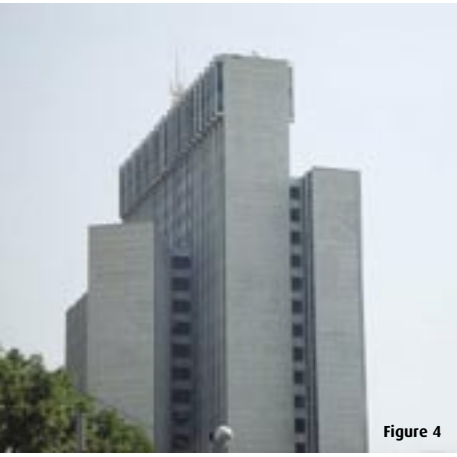
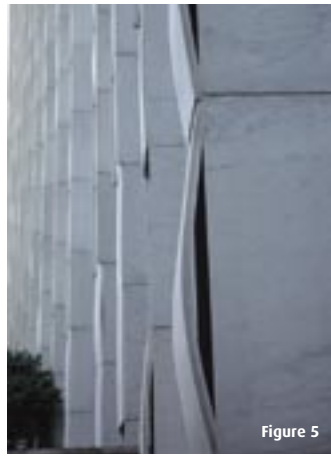
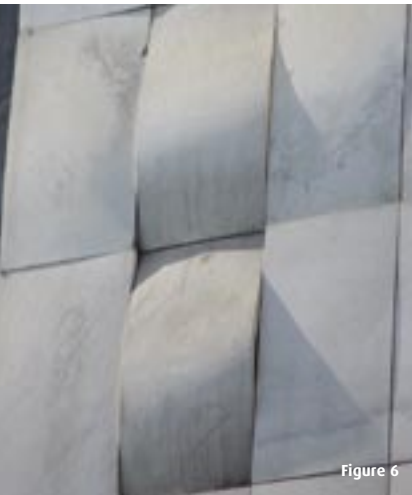
Figures 4-6 Examples from Croatia depict a building façade that exhibits severe bowing. Figure 7 Bowing measurement on a façade.

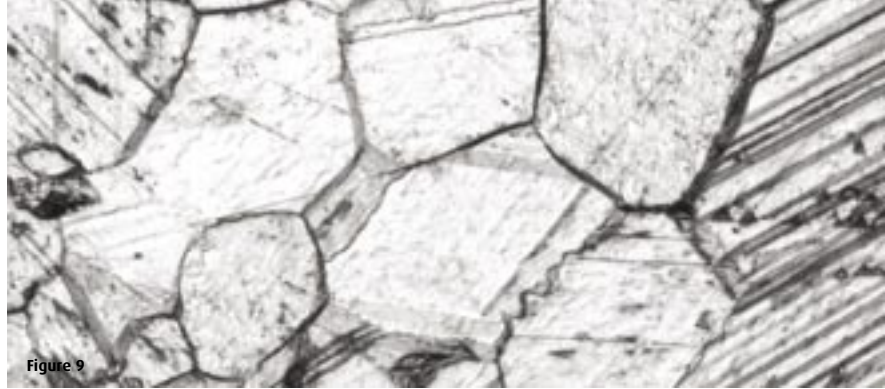
Figure 9 Microphoto (1.0x 1.5 mm) Carrara marble with granoblastic microstructure, marble with potential bowing behaviour.

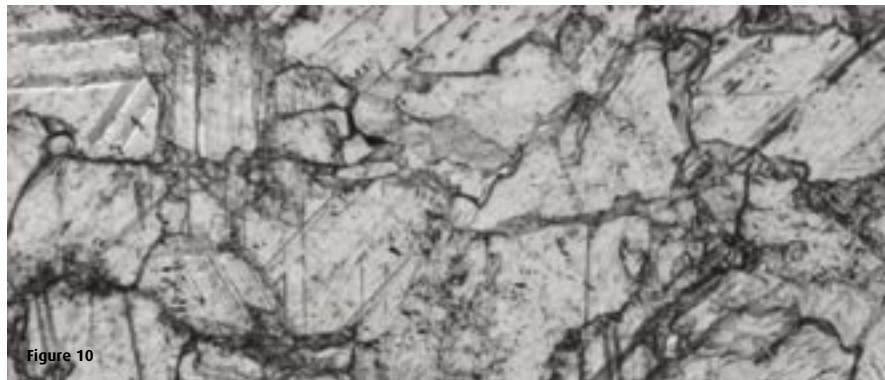
Figure 10 Microphoto (1.0x 1.5mm) Carrara marble with xenoblastic microstructure. A marble that does not bow.
