# out damn spot

(or not, as the case may be)....

The following article explains some recurring problems with limestone and other porous paving materials. It does not conclude that limestone is unsuitable for these purposes. Nevertheless, there is always a risk that it will be misconstrued as a broad condemnation of limestone. The causes of the unsatisfactory results illustrated here are not inherent shortcomings in the paving materials themselves. These problems recur due to a failure to appreciate and make allowance for characteristic properties which differ from those of more familiar granites, dense marble, basalt, reconstituted stone and porcelain tiles. If appropriate precautions are taken in design and installation of paving and flooring of relatively porous stone, these problems can be avoided.

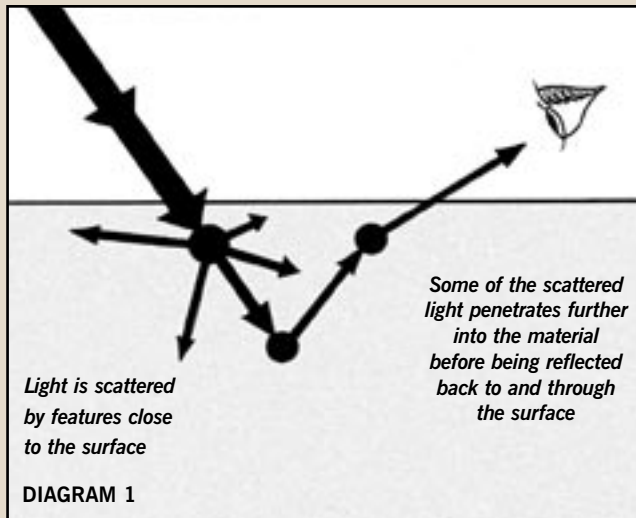
Diagrammatic representations of reflection of light from a dry surface and wet spot optics, i.e. dark “damp” discolouration from deposition of clear and translucent materials in pores close to the surface of natural stone and ceramic tiles.

There are two components of reflected light; (a) that reflected directly at the surface, which is characteristic of the material's colour, and (b) that which is scattered, reflected and diffracted by textural features of the surface. It is the scattered light which lightens the dry surface and dilutes the true colour of the object. In the diagram below, light passing into a rough dry surface is immediately scattered. Some component of the incident light is reflected and re-reflected back to the surface, then refracted towards the viewer.

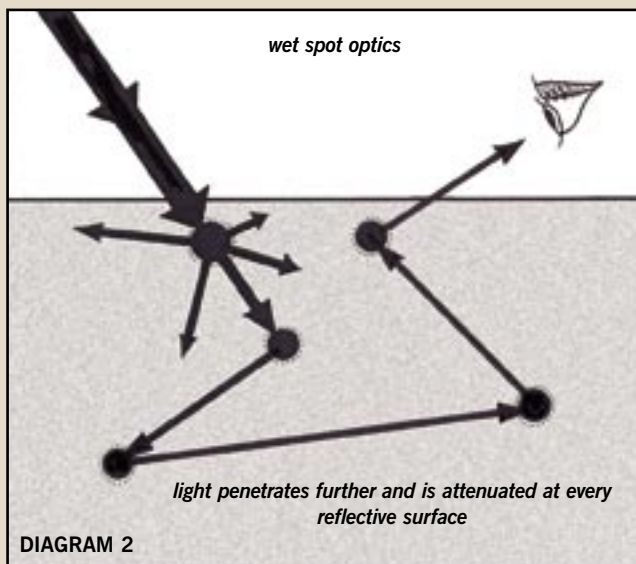
When the surface is moistened, the structures which scatter light are coated with a thin layer of water. By reducing the amount of light reflected from the surface towards the viewer, the thin coating of water makes the object appear darker. The dark appearance is closer to the object's true colour when viewed in unscattered reflected light. For the same reasons, a smooth polished stone surface is typically darker than a honed surface, a wet polished stone surface is darker than a dry polished stone surface, electro-polished stainless steel is darker than

finished stainless steel, a glazed tile is darker than the same tile unglazed and a drop of water on cloth or paper creates a dark spot. In the diagram below, the film of water in a damp surface forms an anti-reflection coating on the textural features that scatter light. A smaller proportion of light is reflected at each interface.
